COUNTRY: UNIDENTIFIED 4 MAY 1966
 SUBJECT: Exploitation of Metallic Fragment from Unidentified Flying Object
 DATE DISR: 4 MAY 66
 NO. PAGES: 2
 REFERENCES: [REDACTED]

On file in CIA Library is an exploitation report on a metallic fragment approximately 2"x2"x1", recovered near Kerekene, Republic of the Congo. The fragment was recovered by ground search after a UFO fell to earth in the area. The report concludes that the fragment was originally part of an electrical component and was constructed of 0.010-inch thick silicon-steel laminate.

FRAGMENT, METAL, RECOVERED IN THE REPUBLIC OF THE CONGO,
BELIEVED TO BE AN UNIDENTIFIED FLYING OBJECT
(COUNTRY UNIDENTIFIED) (U)
MCN-25500

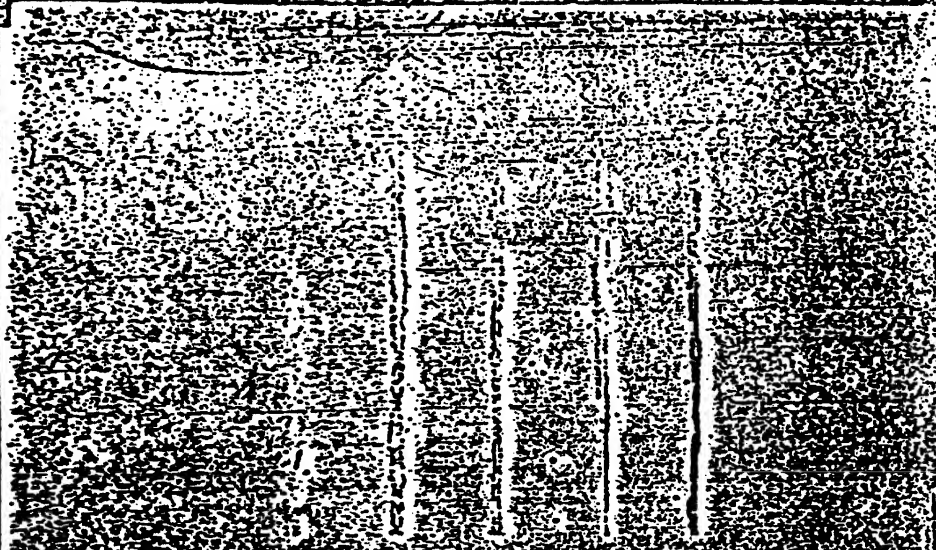
Figure 9 (a) Mirror Picture
of the
Regulation of
(C. Nical Etch)

11. (C) Another result of intense heating was the enlarged grain size of the steel laminates' microstructure. The microstructure of the laminates shown in Figures 9 and 10 illustrates grain sizes that are comparable to Company 2 of ASTM Grain Size Standards. The large grain size indicates that the steel was heated to a high temperature during the process.

12. (C) The light material between the laminations in Figure 9 is plated copper that melted and flowed between the laminations when the entire specimen was hot. A photomicrograph of this is shown in Figure 11.
